FLI IDENTIFIES FIVE LEAK PATHS IN TWO HIGH TEMPERATURE SUSPENDED GAS WELLS AHEAD OF SCHEDULED P&A OPERATIONS.

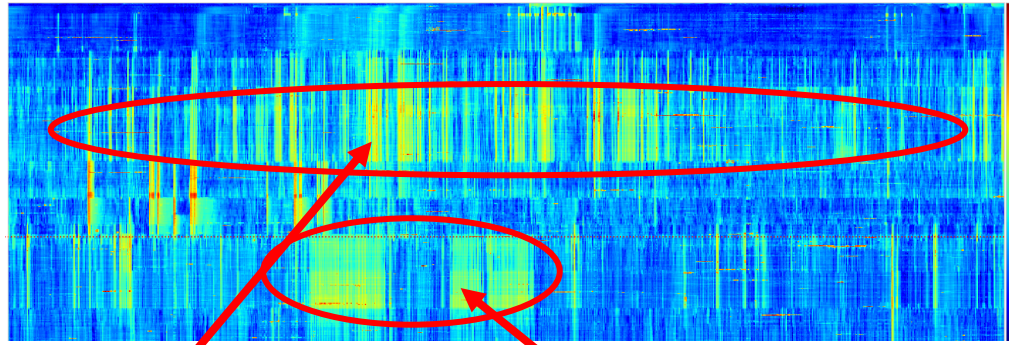
Well 2, Leak Path 1:

Signal indicating flow through cement channels above SC shoe.

Signal indicating flow past formation below SC shoe shortly after SC bleed off.

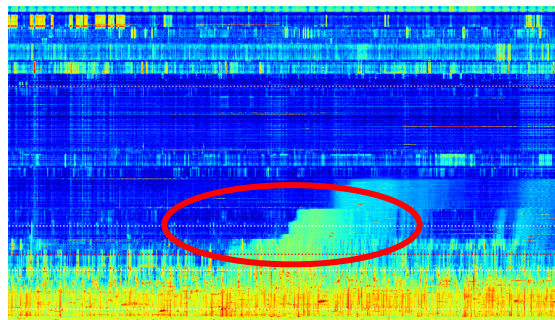
Well 2, Leak Path 2:

Signal from logging depth showing upwards pressure plume through PC plugs.
