FIBERLINE INTERVENTION

FLI IDENTIFIES FIVE LEAK PATHS IN TWO HIGH TEMPERATURE SUSPENDED GAS WELLS AHEAD OF SCHEDULED P&A OPERATIONS.

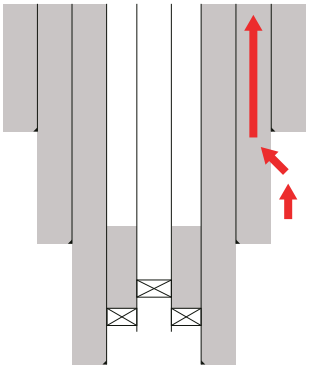
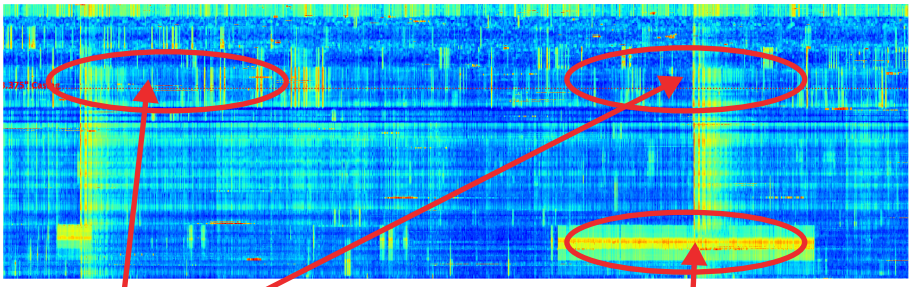
Well 1, Leak Path 1:

Events centred at SC shoe indicate flow

Fluid movement past formation shortly after SC bleed off

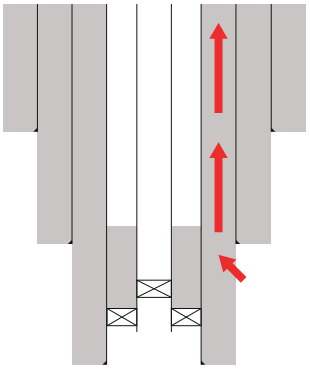
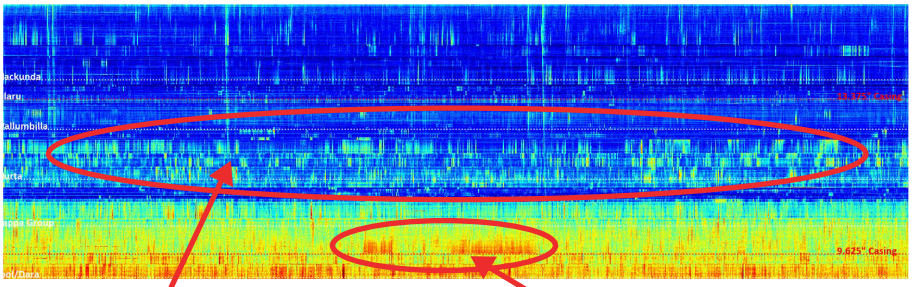
Well 1, Leak Path 2:

Signal from tortuous flow path above IC shoe

Activity at the IC shoe indicates leak entry point

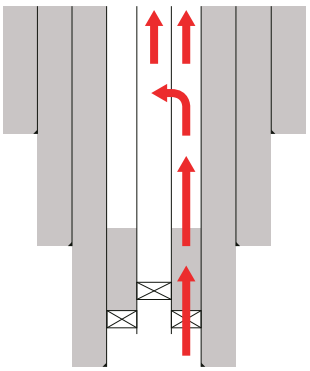
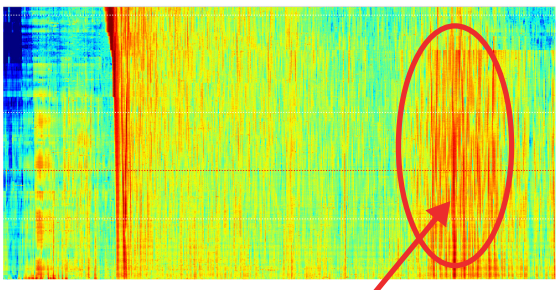
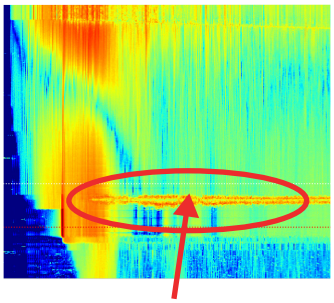
Well 1, Leak Path 3:

Leak through PC from below fibre depth shortly after PC bleed off

Tubing leak at 906m

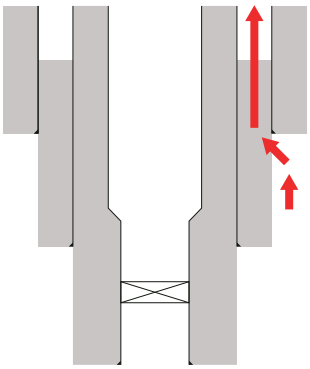
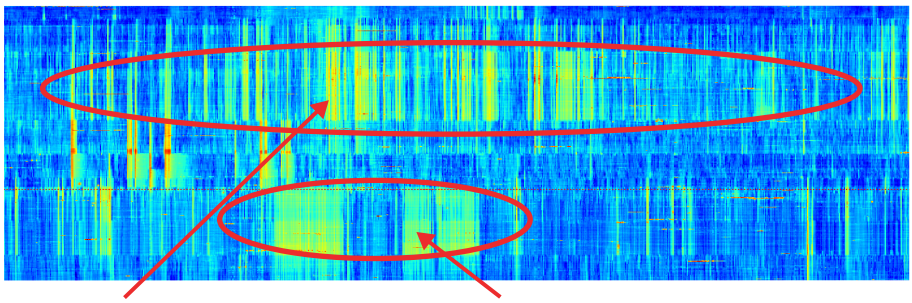
Well 2, Leak Path 1:

Signal indicating flow through cement channels above SC shoe

Signal indicating flow past formation below SC shoe shortly after SC bleed off

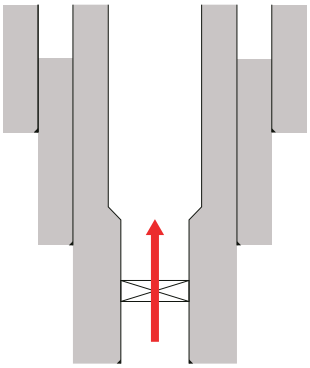
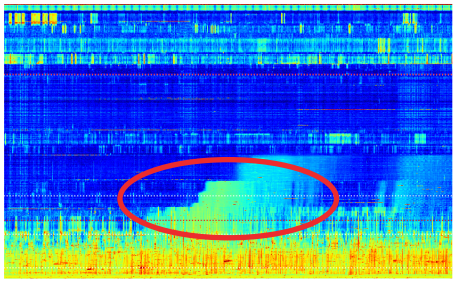
Well 2, Leak Path 2:

Signal from logging depth showing upwards pressure plume through PC plugs

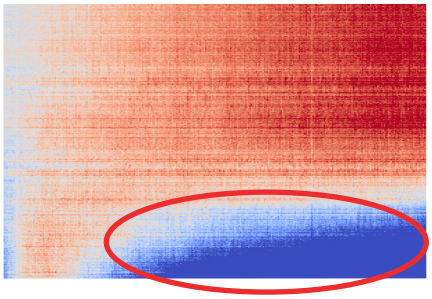
Cooling effect above PC plugs due to gas expanding as it passes through plug leak path
